October 10, 2019

Subject: Retaining Wall and Slope Stability Assessment
Miller Park Path
900 South and Red Butte Creek
Salt Lake City, Utah
Project No. 1190653

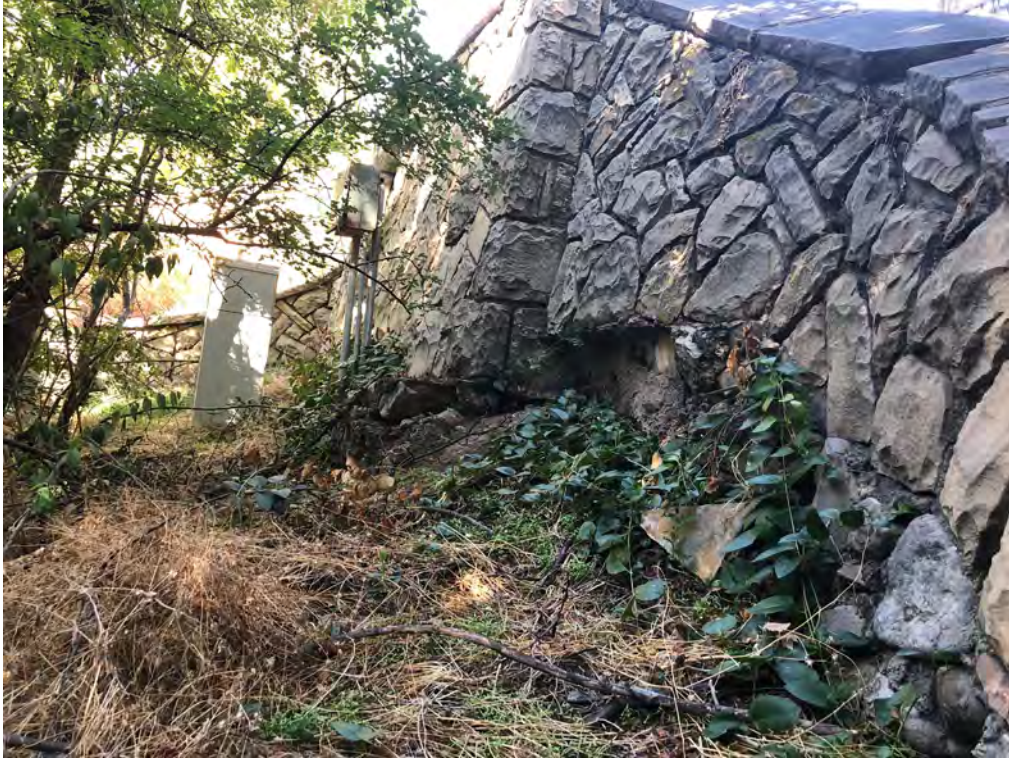
Near the entrance to the park, where the stairs extend down from 900 South, there is an area where the rock wall has been undercut (see Photograph 1). There is a lower tier of rock wall in this area that has significant cracking in the mortar between the rocks (see Photograph 2).

Photograph 1 - Undercut wall near the north park entrance at 900 South.

7. The area at the north end of the park, adjacent the stairway from 900 South where the rock wall has been undercut (see Photograph 1) will be difficult to repair with the steep slope beyond the toe of the wall and the additional wall below. Soil nails or anchors with shotcrete may be a possible method of improving this area.

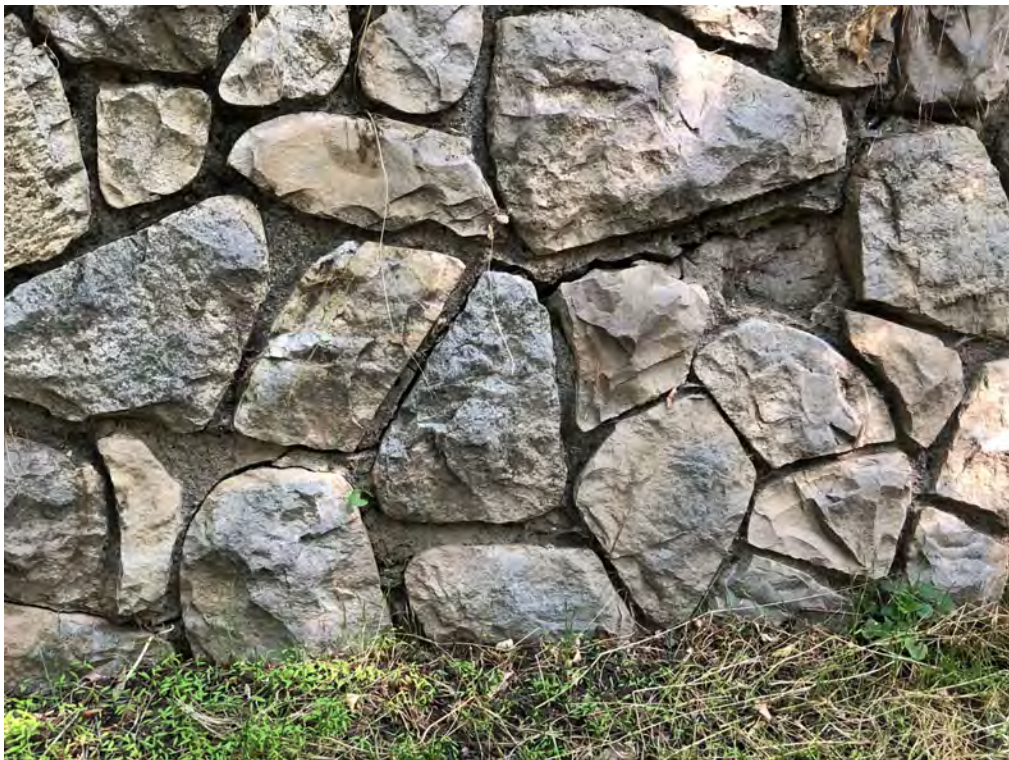
Photograph 2 - Cracks in lower-tier wall near north park entrance at 900 South.

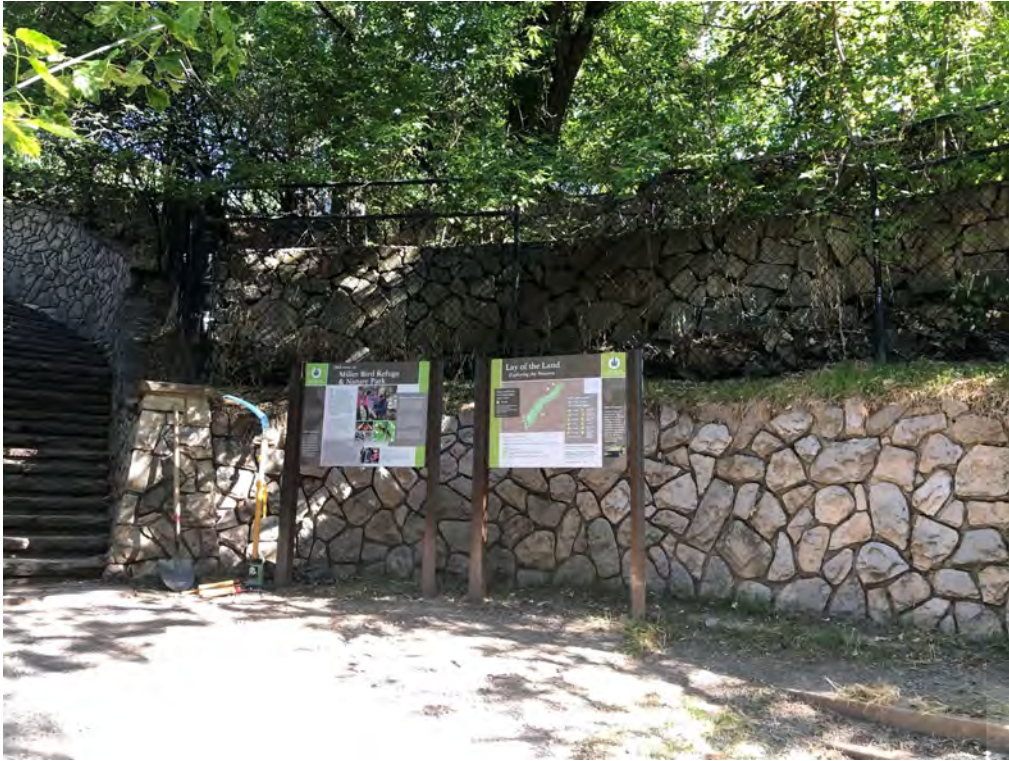
There is a retained slope constructed with broken pieces of concrete slab above the rock wall in this area that appears to have added significant load near the top of the rock wall (see Photographs 3 and 4).

Photograph 3 - Retained slope constructed above the top of the rock wall.

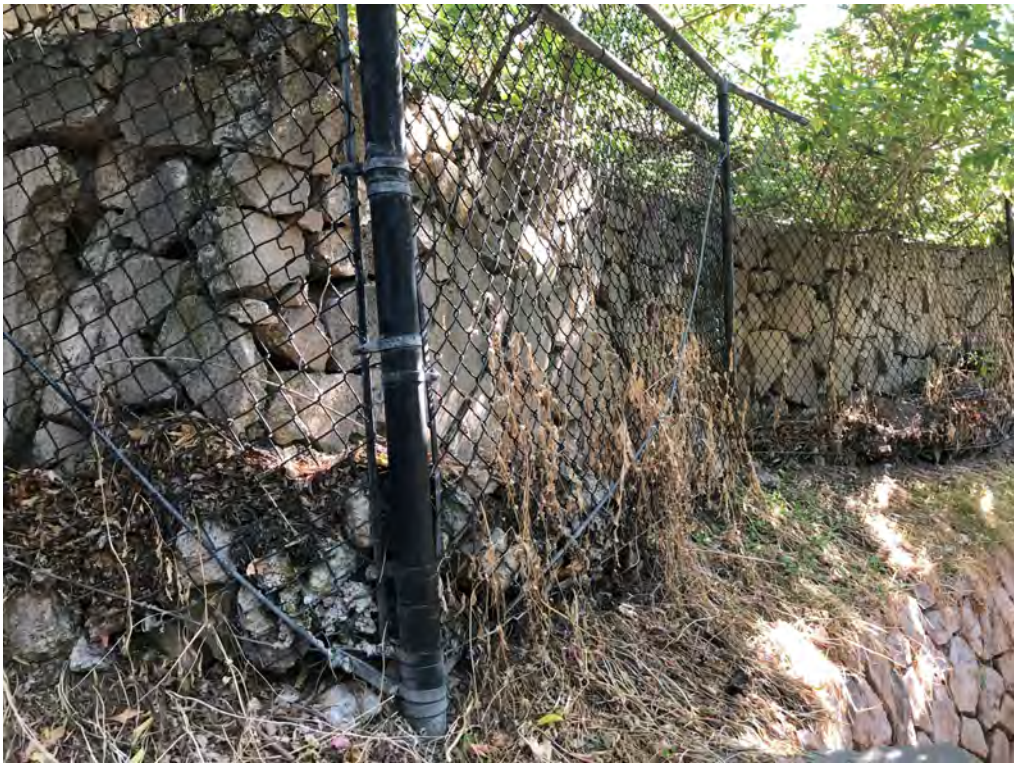
Photograph 4 - Retained slope constructed above the top of the rock wall.

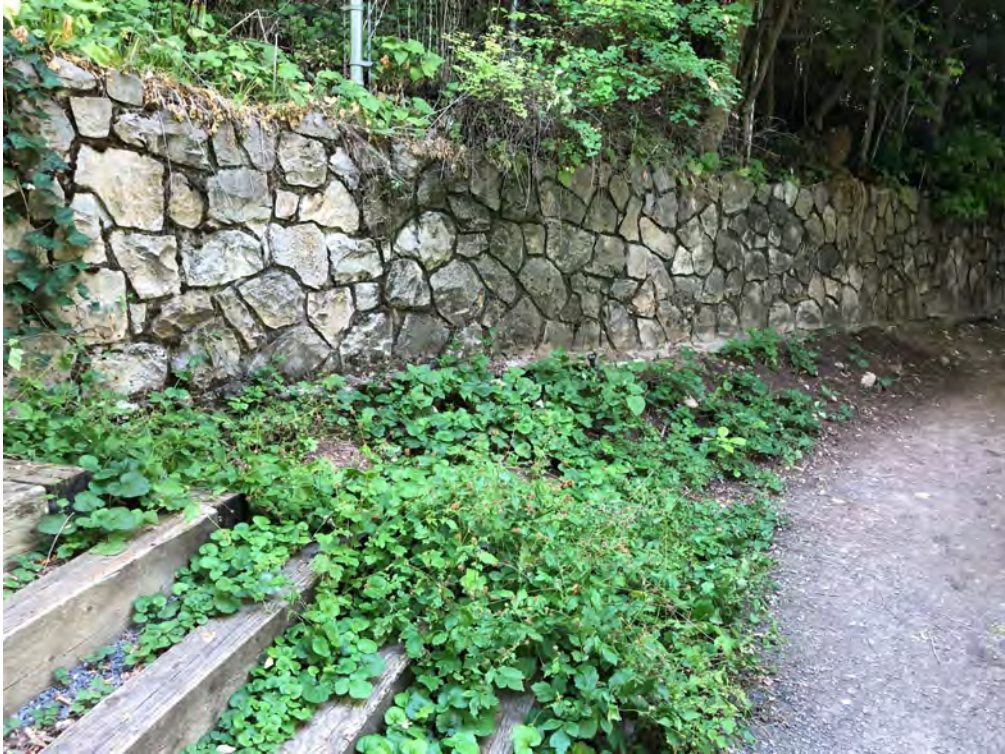
An amphitheater was constructed during recent improvements at the park utilizing timbers to retain the soil (see Photograph 5). The ground beyond the toe of the rock wall adjacent to the south side of the amphitheater has been lowered. This lowering of the ground reduces the stability of the rock wall.

Photograph 5 - Ground below the rock wall has been lowered.

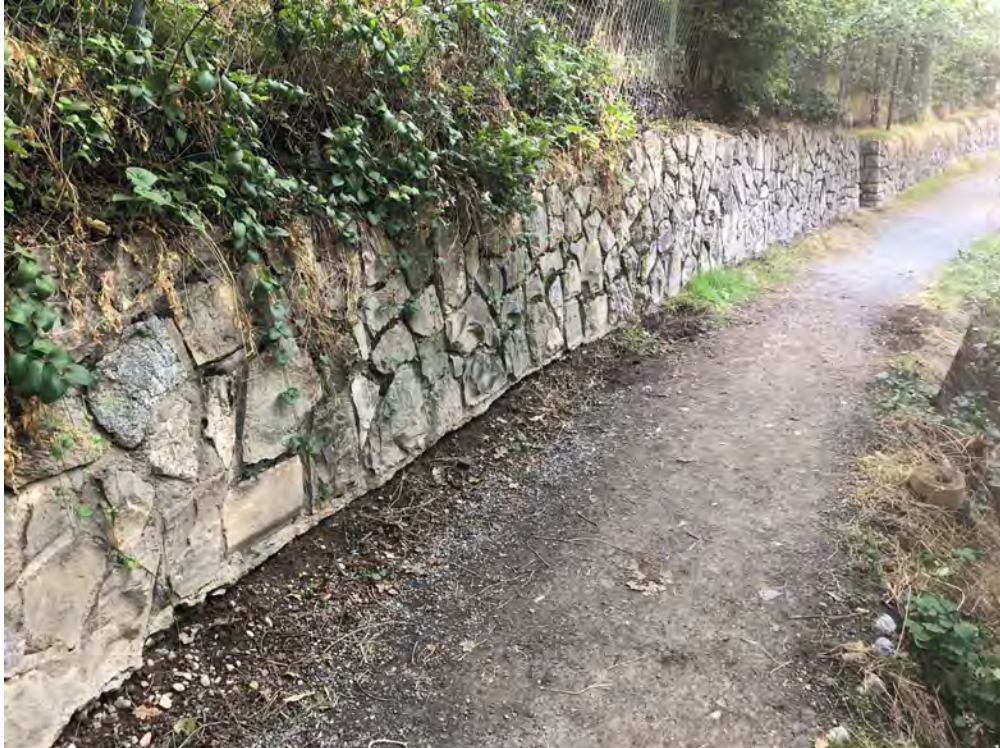
There are areas where it appears that soil has been removed at the base of the rock wall (see Photograph 6).

Photograph 6 - Ground at toe of wall appears lower than base rock.

2. Crib walls in poor condition could be replaced with new crib walls, gabions, mechanically stabilized retaining systems or other systems.
3. Consideration may be given to replacing the soil cover at the base of undercut rock walls. This would likely be in conjunction with improving the retaining systems (such as crib walls) on the downhill side of the trail.

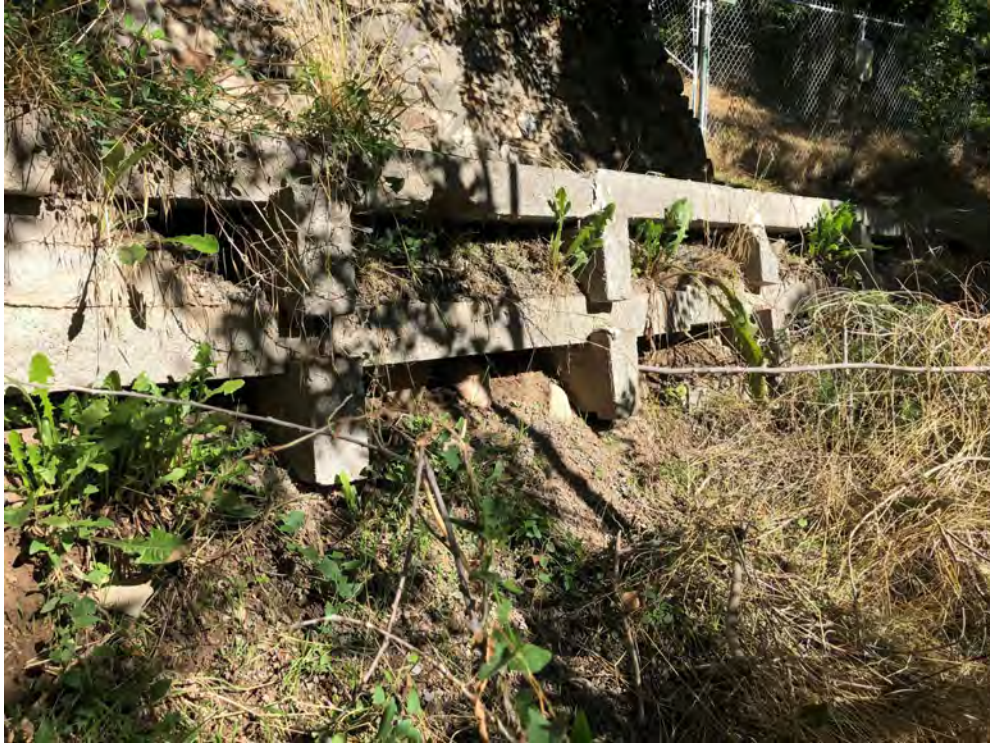
There are several areas of crib wall on the downhill side of the trail along the west side of the creek. The crib wall is in relatively poor condition where soil appears to have eroded from the crib wall and undercut the wall (see Photograph 7).

Photograph 7 - Crib wall on west side of creek has experienced erosion and undercutting.

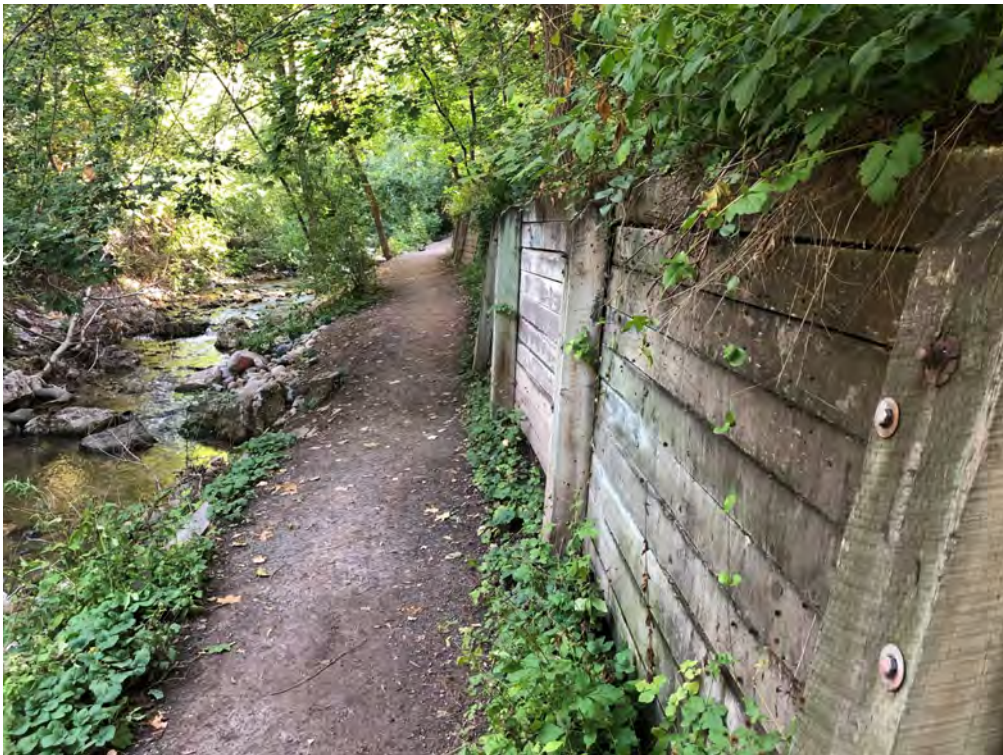
There is a timber retaining wall that appears to have soil anchors. A portion of this wall appears to be bulging or the top has rotated out away from the slope (see Photograph 8 and 10). Soil is exposed below the lowest timber lagging.

Photograph 8 - Timber wall section appears to have rotated away from slope.

6. Consideration should be given to further evaluation of the timber wall in the area where it appears to be rotating or bulging (see Photographs 8 and 10). Additional retaining systems on the toe side of this wall could be considered to buttress the wall and raise the grade of the trail below the wall. This is also an area where there are crib walls that should be considered for replacement on the creek-side of the trail.

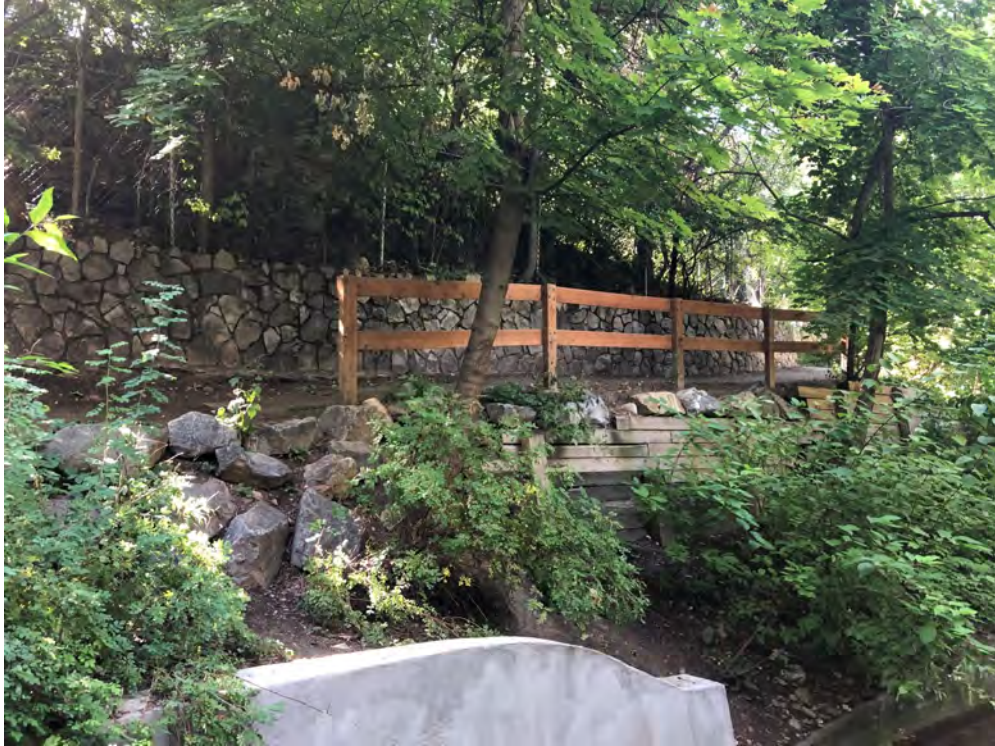
An area of the timber wall was modified near the north end of the trail on the east side. Additional height was added to the timber wall and it does not appear that additional soil anchors were provided (see Photograph 9).

Photograph 9 - Newer timbers added to the top of the older timber retaining wall.

5. We anticipate that when the timber wall was increased in height at the north end of the park, they may not have considered overall stability of the wall with the increased height (see Photograph 9). The stability of this wall should be reviewed and could be improved as needed. We anticipate that the area above this wall may be raised with additional fill to provide embedment of the rock wall above. Consideration could be given to reconstructing or improving the timber wall to facilitate the increased height.

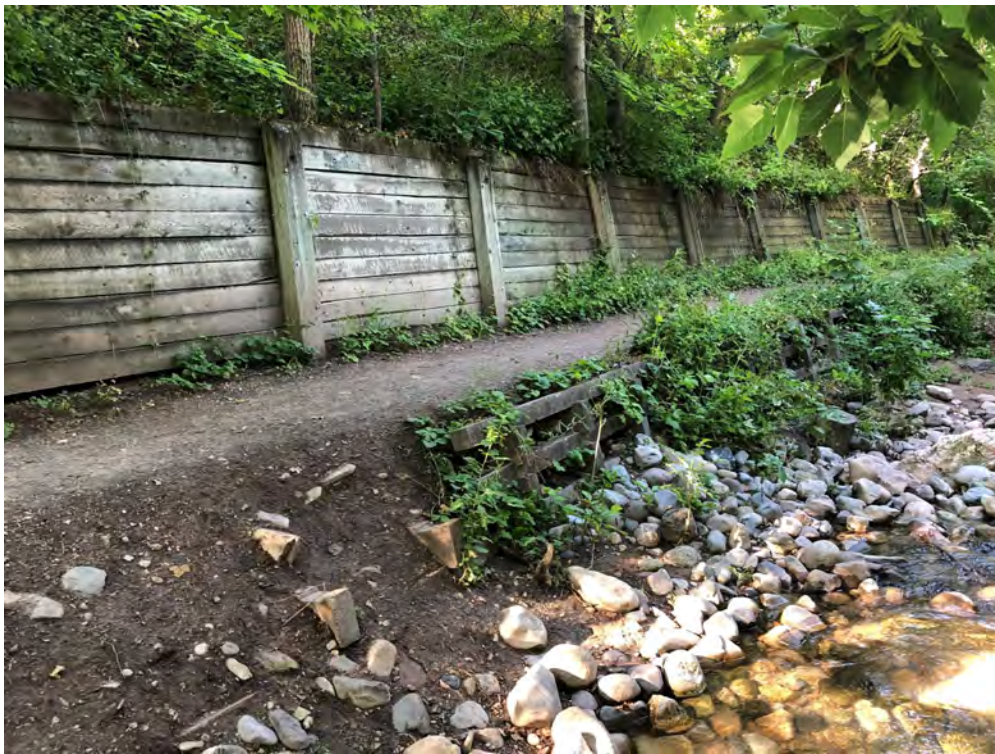
There are areas of crib wall on the downhill side of the trail along the east side of the creek. Like the crib walls on the west side, these walls appear to be in poor condition where soil has eroded from the crib wall units (see Photograph 10).

Photograph 10 - Crib wall on east side in poor condition. Timber wall above appears bulging or rotating.

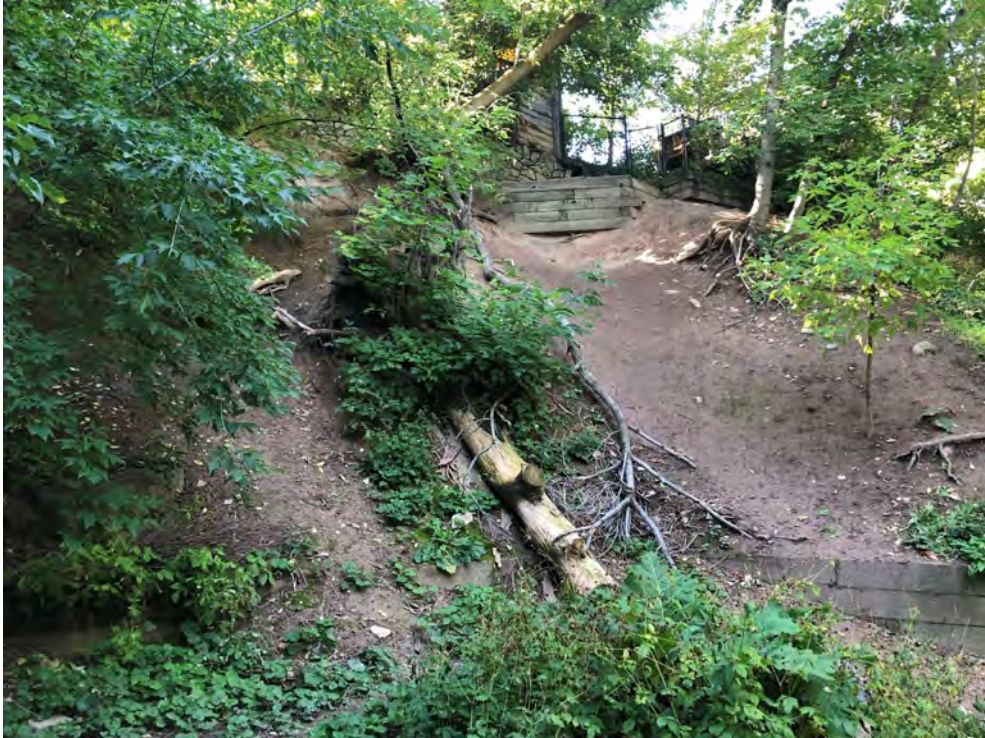
There are localized areas of significant erosion adjacent the rock wall on the east side of the creek (see Photograph 11). The rock wall in the area of this photograph can be seen near the top of the photograph, above the area of erosion. Photograph 12 is taken above this area and shows the rock wall with trees and structures near the top of the wall.

Photograph 11 - Area of erosion above the trail on the east side of the creek. The rock wall is seen near the top of the photo, above the area of erosion.

1. Erosion protection measures could be considered for areas that are experiencing erosion problems. Such measures could include regrading and/or providing additional retaining structures to flatten exposed slopes and control runoff, revegetation, eliminating access to slopes, providing erosion control mats or other measures.

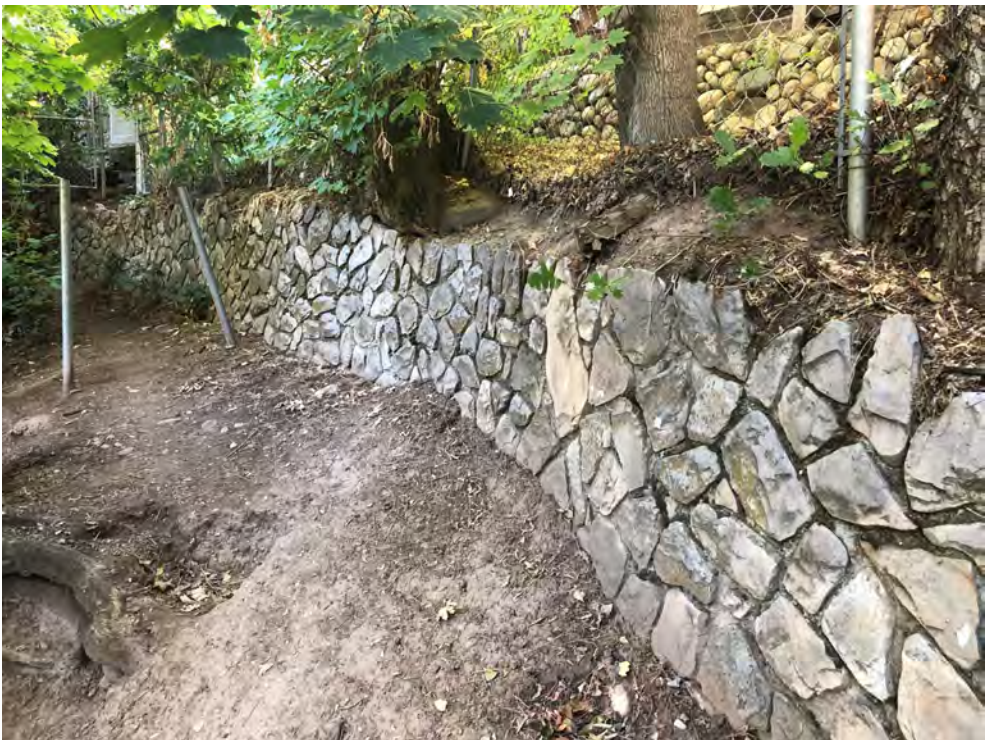
Photograph 12 - Rock wall above the area of erosion. Note trees and other loads near the top of the wall.

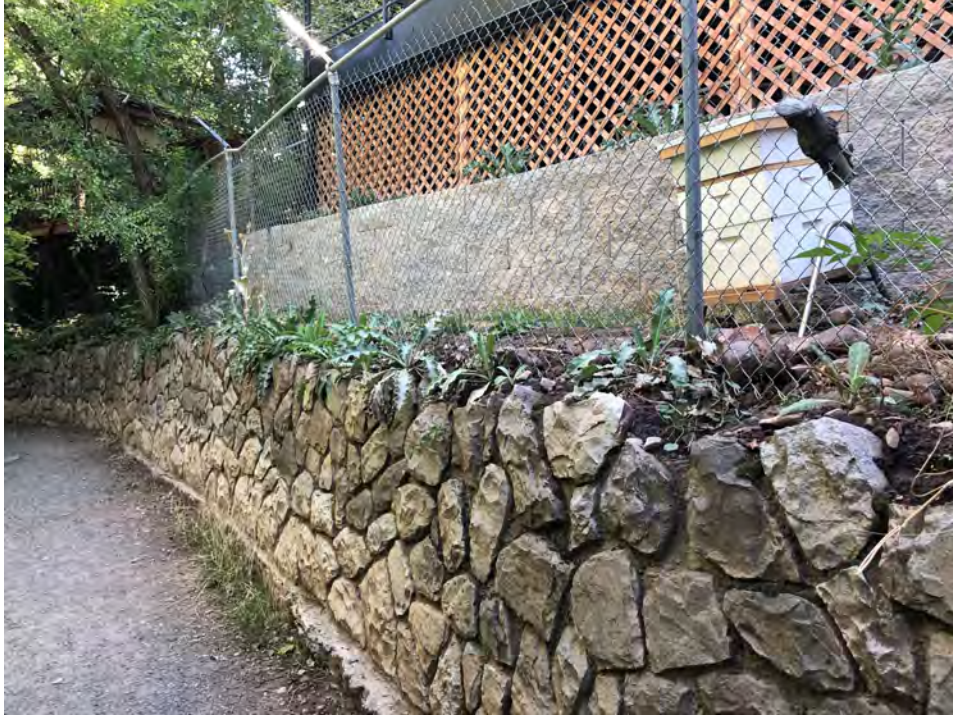
Structures have been placed near the top of the rock wall on the east side of the creek (see Photographs 13 to 15). Photograph 13 shows an area where the rock wall foundation has been exposed.

Photograph 13 - Area on the east side of creek where structures have been placed near the top of the wall. Also shown wall foundation exposed at the toe.

4. The stability of retaining walls may have been reduced where structures have been placed or grade has been raised near the top of the retaining walls. Consideration may be given to evaluating the effect of the structures and increased grade for these walls.

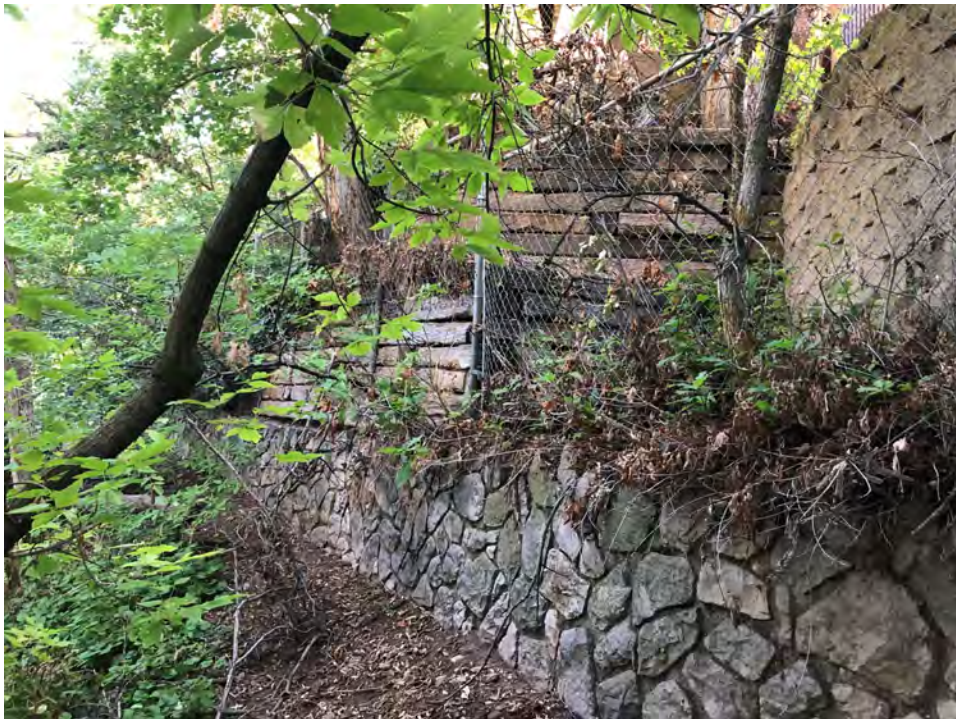
Photograph 14 - Structures encroaching near the top of the rock wall on the east side of the creek.

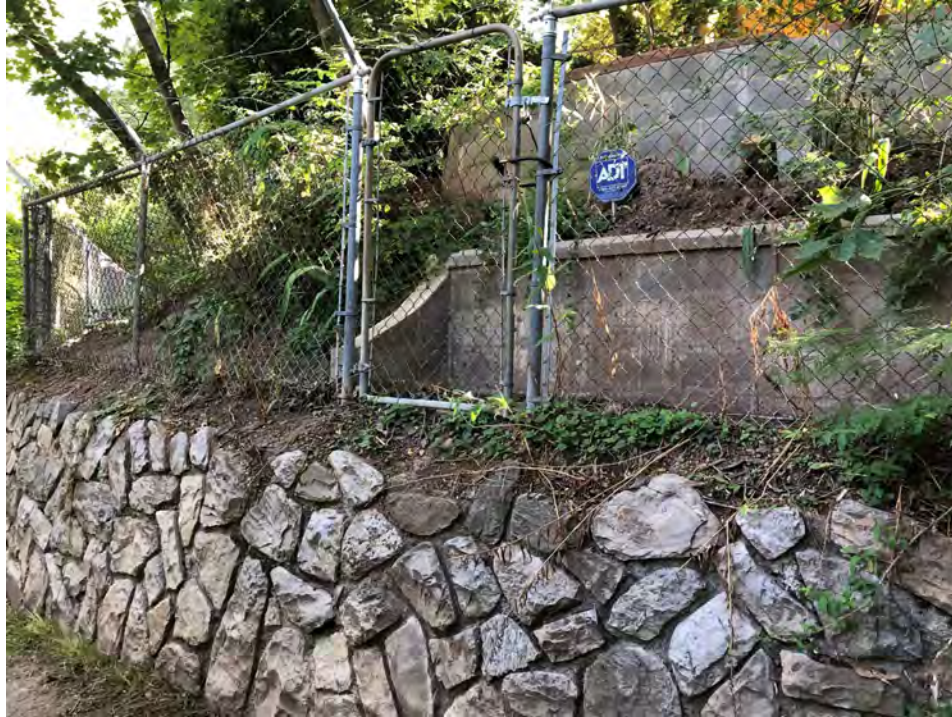
Photograph 15 - Structures encroaching near the tip of the rock wall on the east side of the creek.
