October 3, 2019

Re: Miller Park Retaining Wall Investigation
1708 E 900 S, Salt Lake City, UT
ARW Job # 19075

Photo Appendix

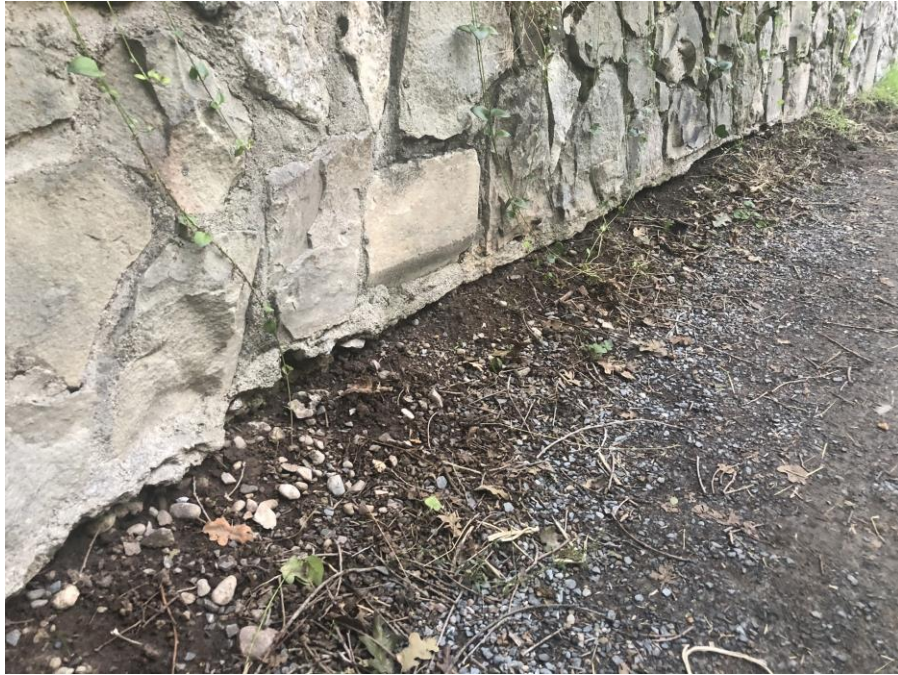
Photo #1 – Soil cover over toe of wall is not adequate

- 6- There are several walls that need to be repaired or replaced due to excessive erosion from sprinklers, drainage pipes and/or poor trail drainage or maintenance. There are also several locations where the toe of the existing rock walls are exposed. These areas need to be repaired with structural fill (and geofabric where needed). Sprinklers above and below trails should be removed where possible to eliminate saturated soil conditions and reduce soil erosion from runoff.

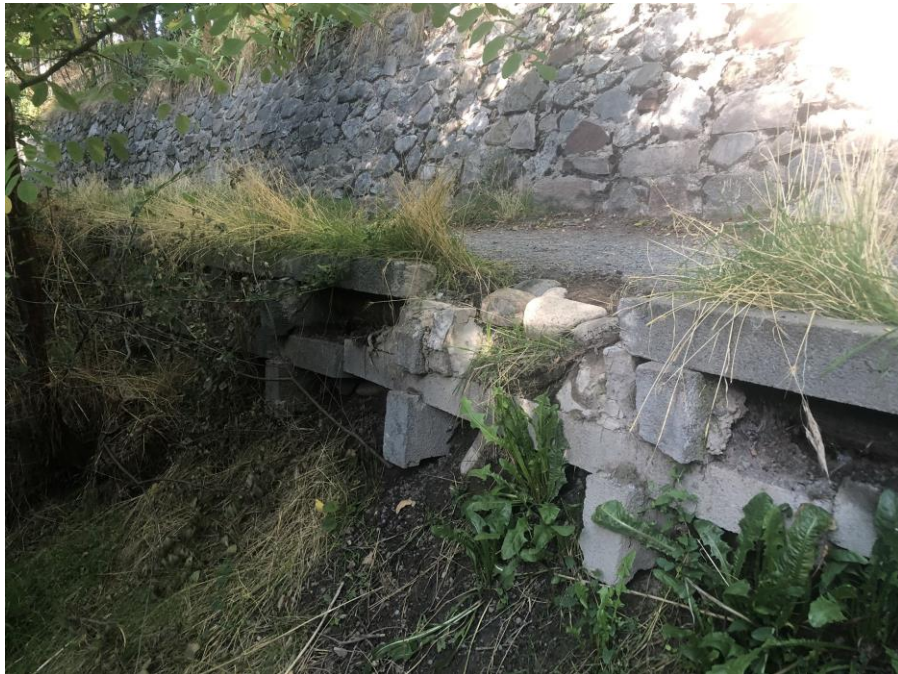
Photo #2 – erosion on the trail due to runoff and sprinklers has cause the crib walls to fail in several locations.

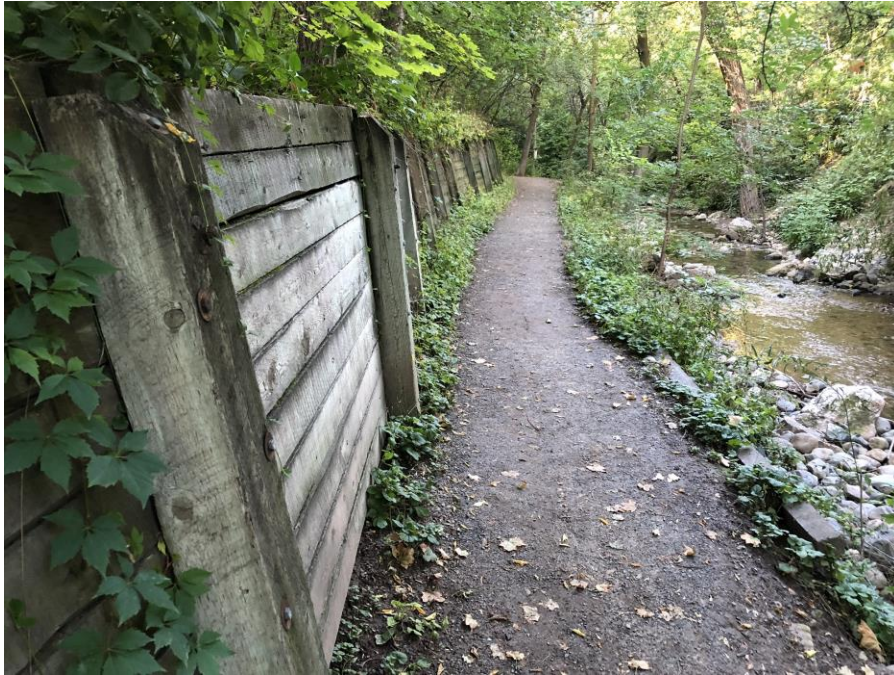
Photo #3 – Runoff from adjacent property owners' gutters is causing the wall to bulge and fail

- 3- Drainage pipes from property owners above the wall need to be addressed. There are several properties that are sending water from their gutters towards the existing retaining walls. This is causing excessive erosion above, behind and below the retaining wall structures. These drainage areas need to be remedied and the water needs to be piped around the wall as required. Addressing drainage issues will also help keep the soil less saturated above the walls.

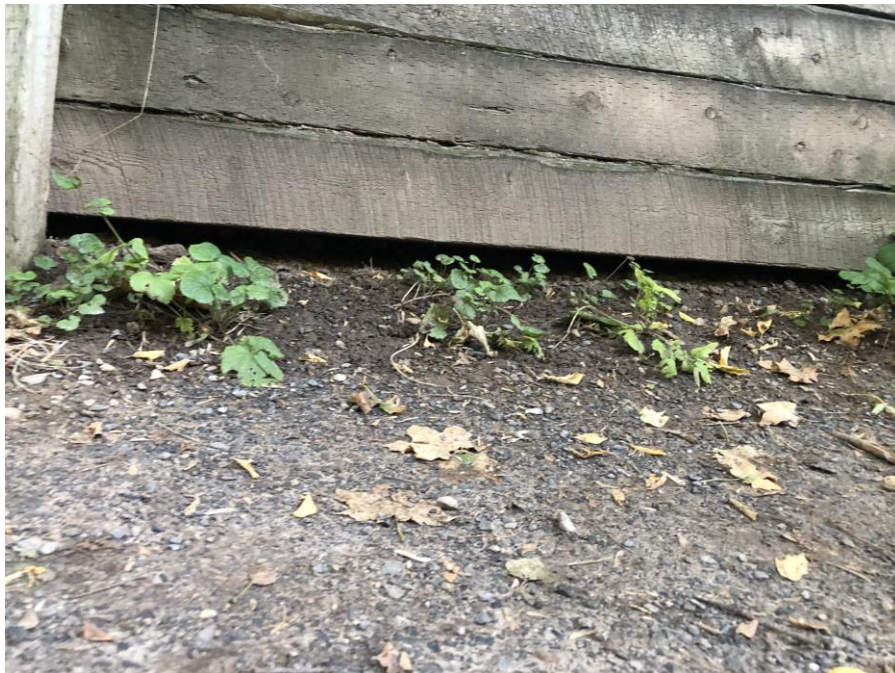
Photo #4 – Runoff from adjacent property owners is undermining existing walls.

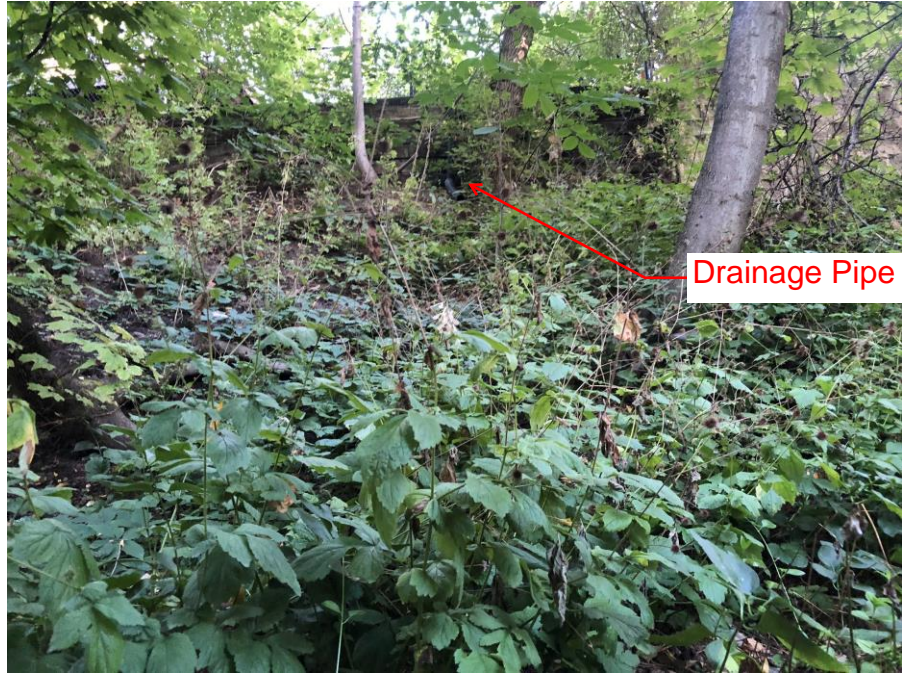
Photo #5 – Image of drainage pipe from neighboring property owners

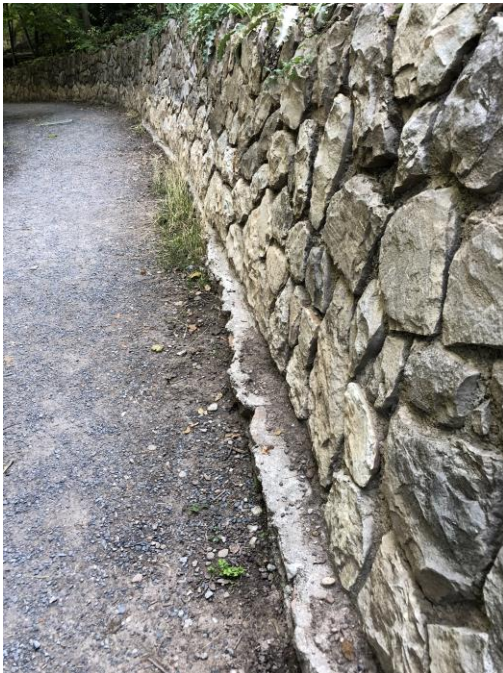
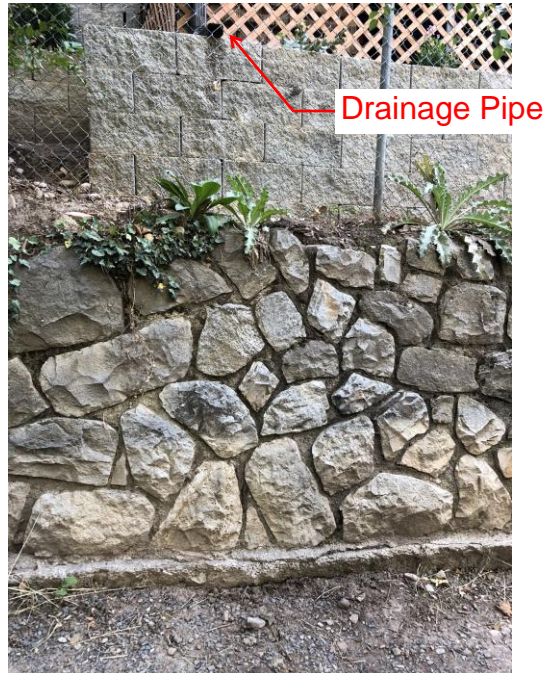
Photo #6 – Image of drainage pipe from neighboring property owners, example of adjacent structures encroaching on the existing rock walls, and example of toe of retaining wall being undermined.

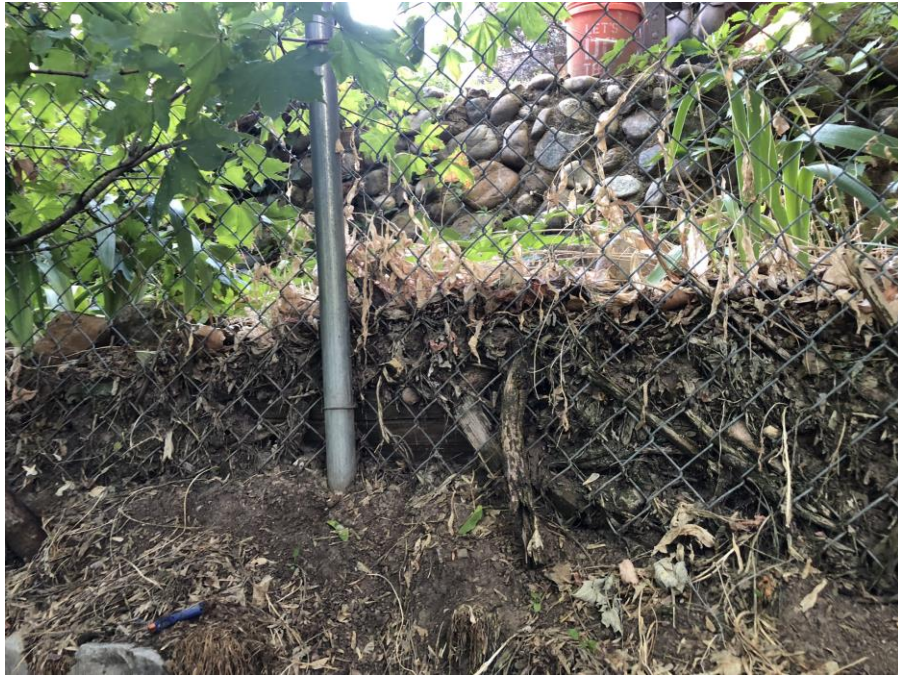
Photo #7 – Chainlink fences are collecting debris from runoff water and are retaining soil.

- 1- Chain link fences above the existing rock walls need to be removed and/or regularly maintained. These fences add additional lateral wind loads to the wall that were not accounted for in the original wall design. Property owners above the fences have not maintained the chain link fences in several areas and there is a build-up of debris against the fence that is increasing the retaining wall height and soil loads on the retaining wall structure below.

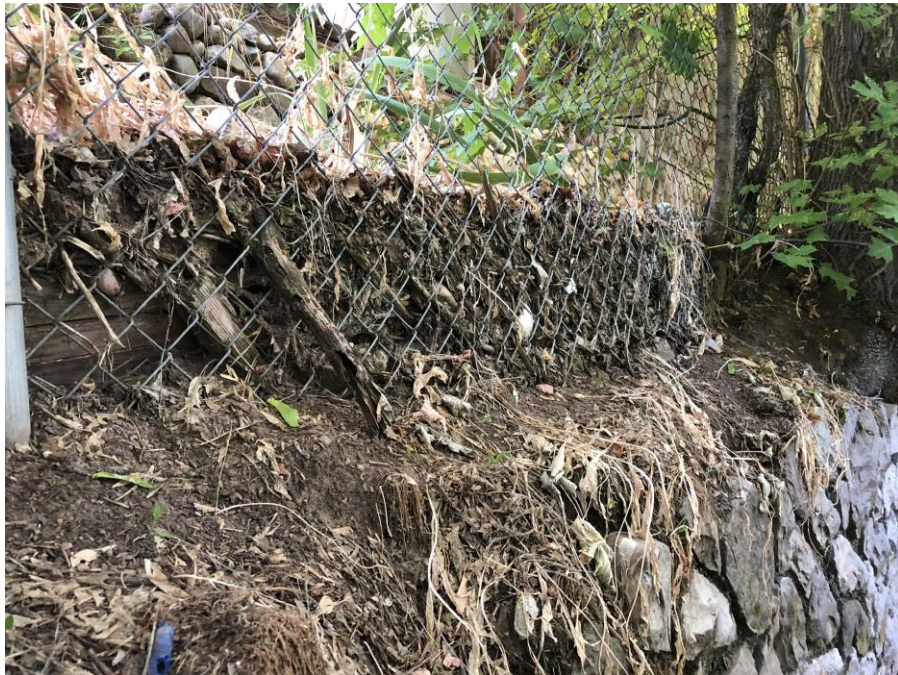
Photo #8 – Chainlink fences are collecting debris from runoff water and are retaining soil.

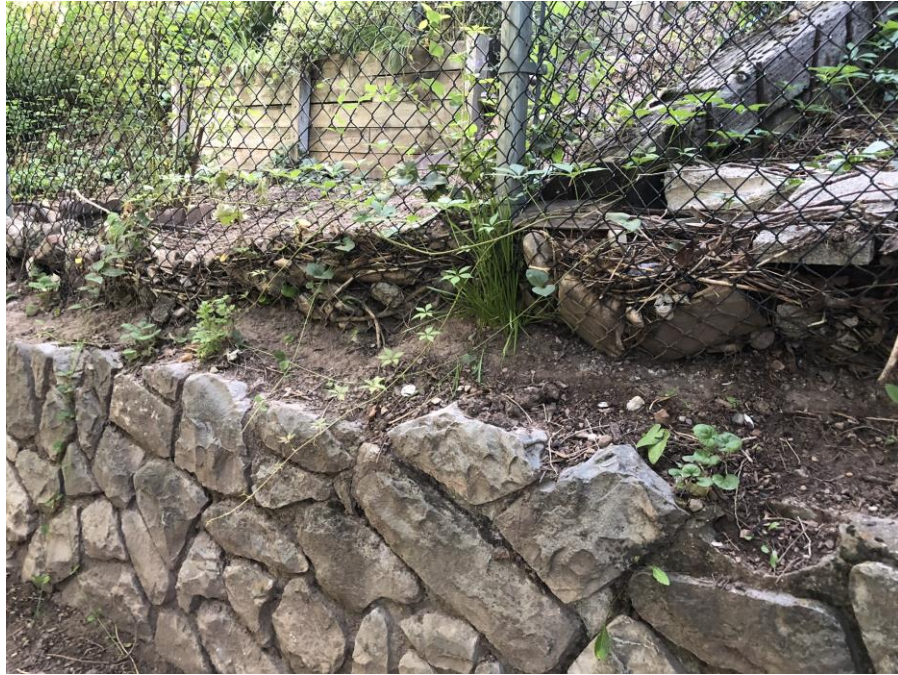
Photo #9 – Chainlink fences are collecting debris from runoff water and are retaining soil.

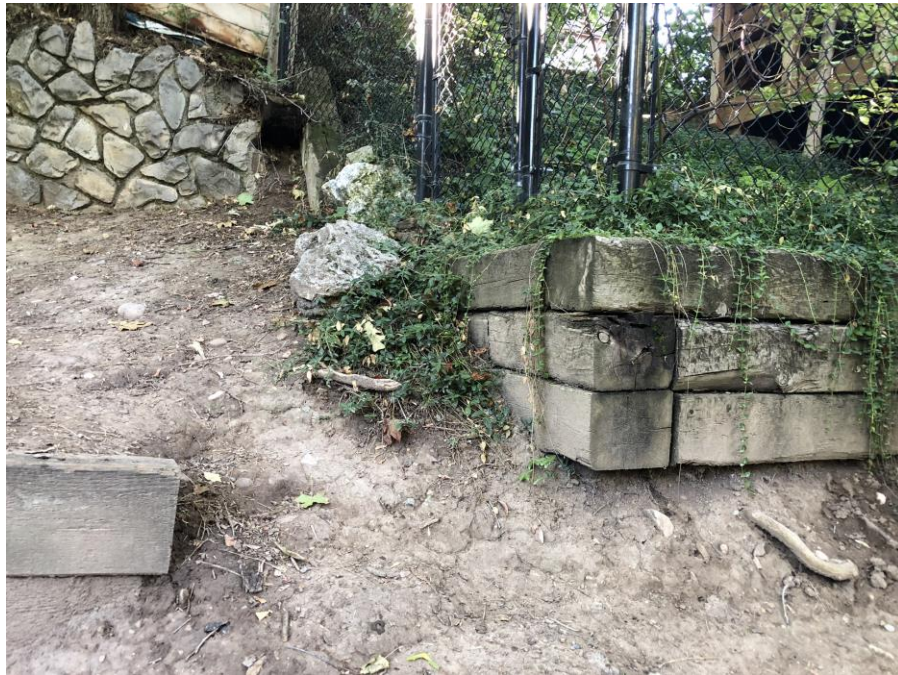
Photo #10 – Image of drainage from neighboring property owners and runoff from sprinklers causing the soil to erode and undermine the existing retaining wall structures.

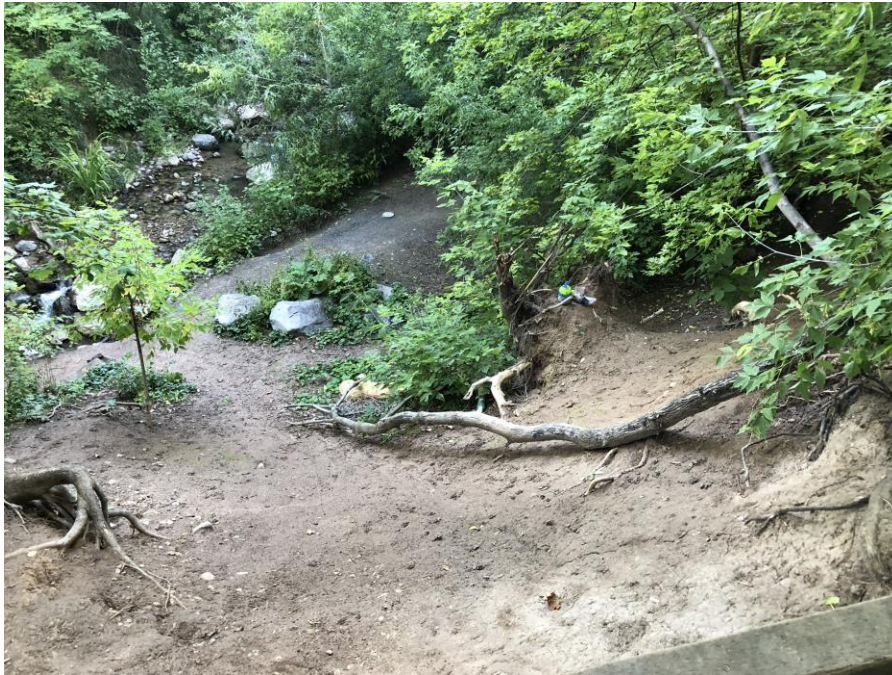
Photo #11 – Erosion that has occurred from sprinklers and runoff from neighboring properties

- 2- Sprinkler systems above and below the wall (maintained by the city and homeowners) are causing excessive erosion behind the wall and in some cases the erosion is undermining the toe of the retaining walls. Retaining walls typically have a pipe drainage system and free draining material (gravel and/or water board) behind the wall so that water does not accumulate against the wall (creating a dam like structure with hydrostatic pressure on the wall). Weep holes are typically incorporated into new retaining wall designs to alleviate hydrostatic pressure behind walls. Eliminating water sources that create saturated soil conditions behind walls will help reduce soil/water loads on the wall and help extend its longevity. Saturated slopes are more prone to erosion and can cause unstable slopes above retaining walls.

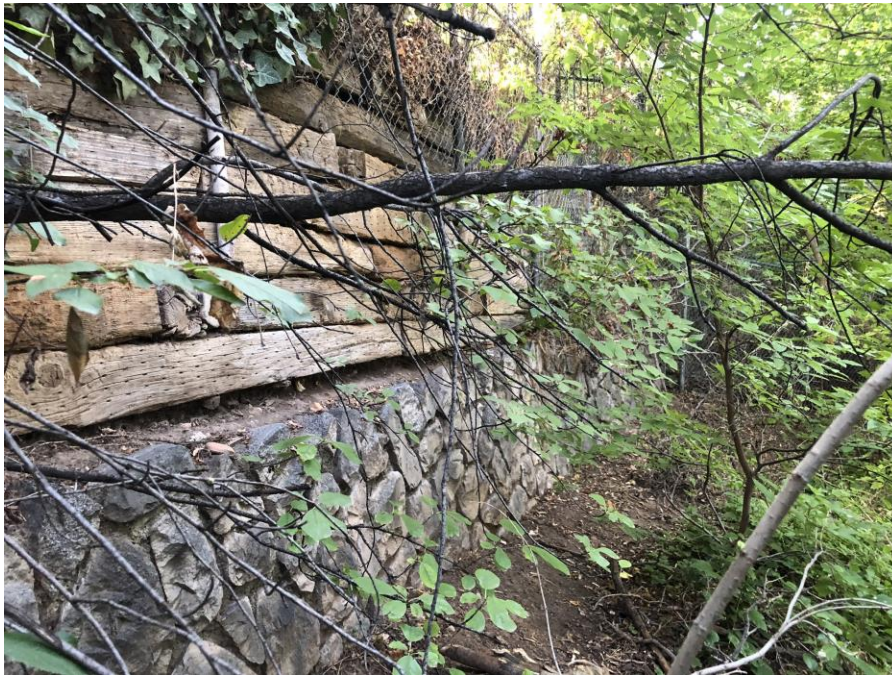
Photo #12 – Example of neighboring property owners building structures above existing rock walls.

- 5- There are several locations where the neighboring property owners have encroached on the existing rock walls with new retaining wall structures or new building structures. This is not advisable because it can increase loads on the retaining wall and cause it to fail. These structures should be removed, or deep foundations should be installed to independently support these structures. This will alleviate the additional lateral loads on the existing walls caused by these structures.

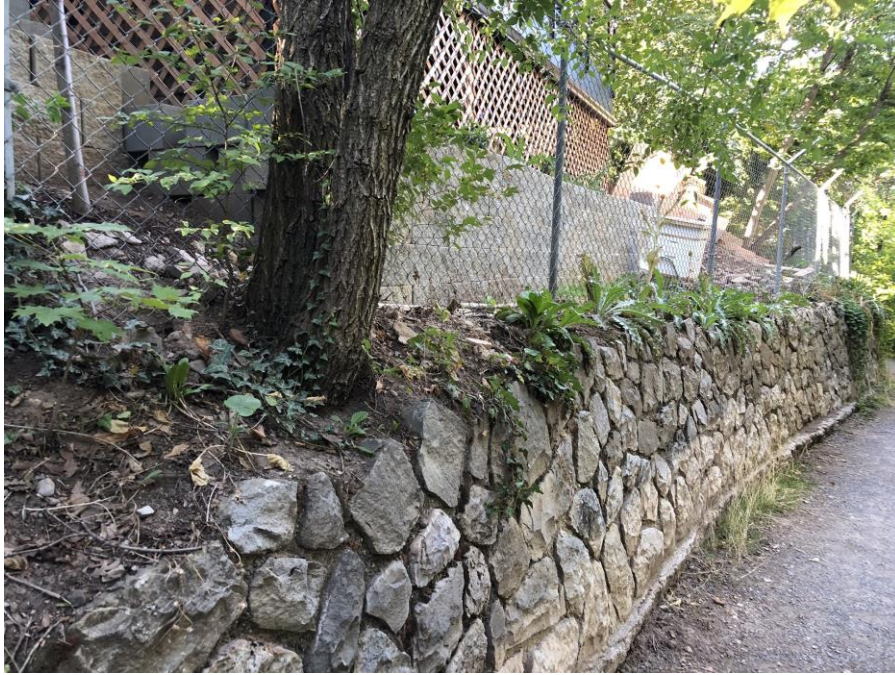
Photo #13 – Example of neighboring property owners building structures above existing rock walls. Trees that occur adjacent to the wall should be removed and the structural fill should be used to backfill over the toe of the existing rock wall.

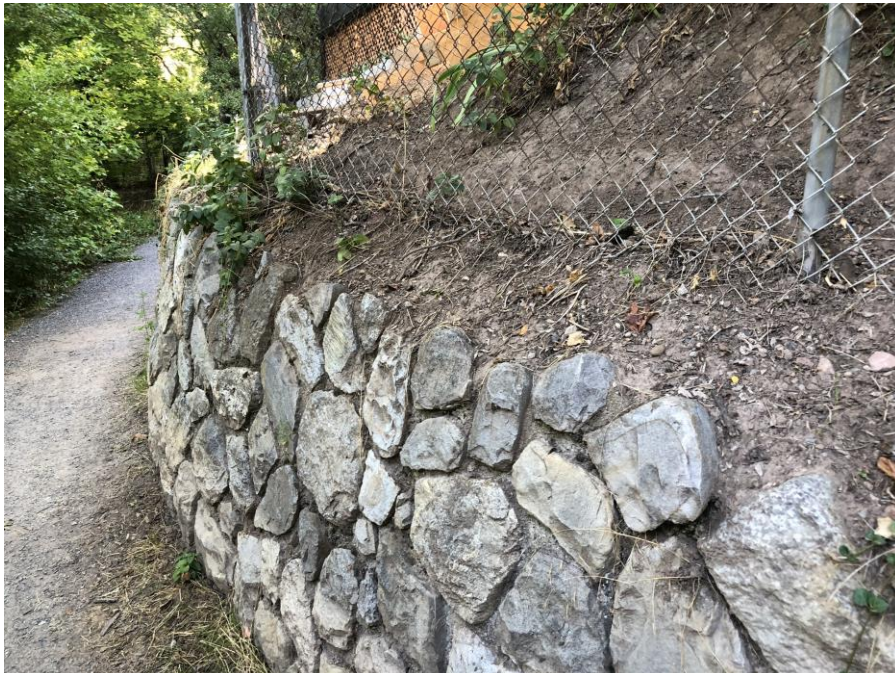
Photo #14 – additional soil has been added above the wall and should be removed

- 4- Trees growing adjacent to the top of the walls need to be removed. The tall trees that occur behind walls can create additional lateral loads and damage to the walls during a wind event. It also appears that adjacent property owners have added excavated soil from their yards to the top of the existing walls. This additional soil load increases the horizontal loads on the wall which can exceed the initial design loads the wall was engineered to retain. This additional overburden from additional soil should be removed.

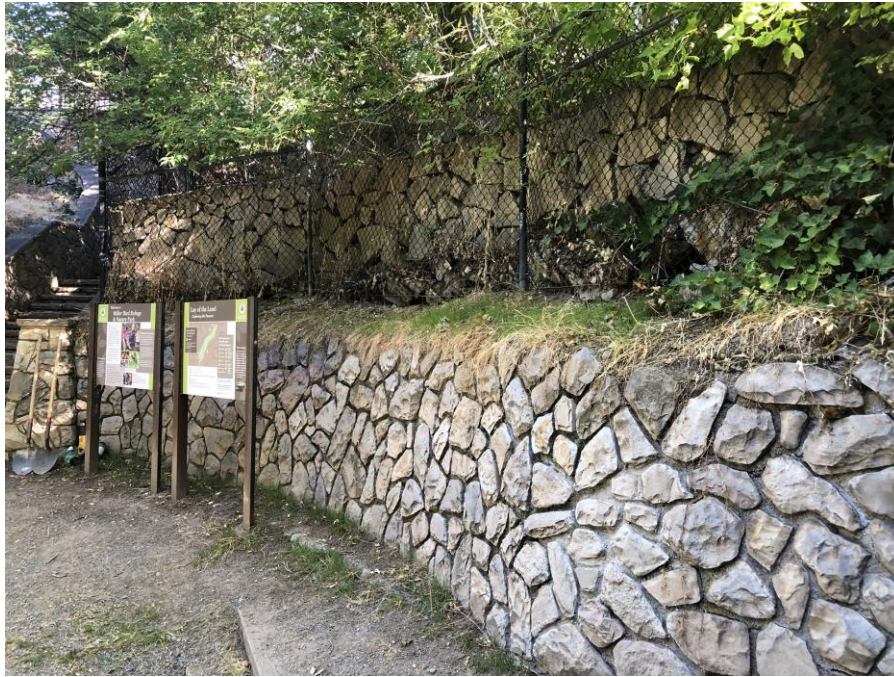
Photo #15 – There is a retaining wall built above the original rock wall that has large rocks caught in the fence. This wall is an example of neighbors building structures above the existing walls and creating additional loads on the existing structure.

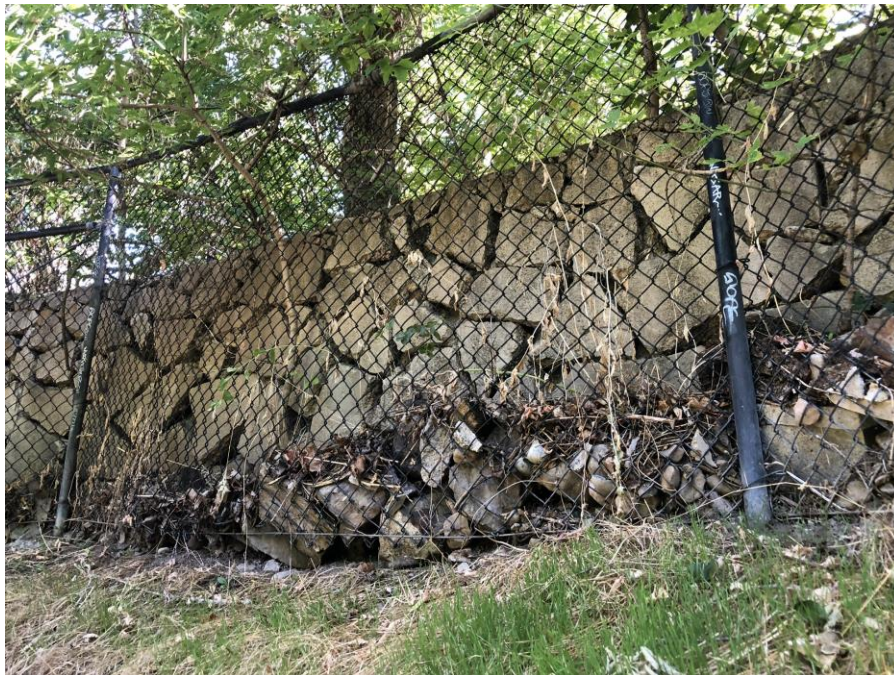
Photo #16 – There is a retaining wall built above the original rock wall that has large rocks caught in the fence. This wall is an example of neighbors building structures above the existing walls and creating additional loads on the existing structure.

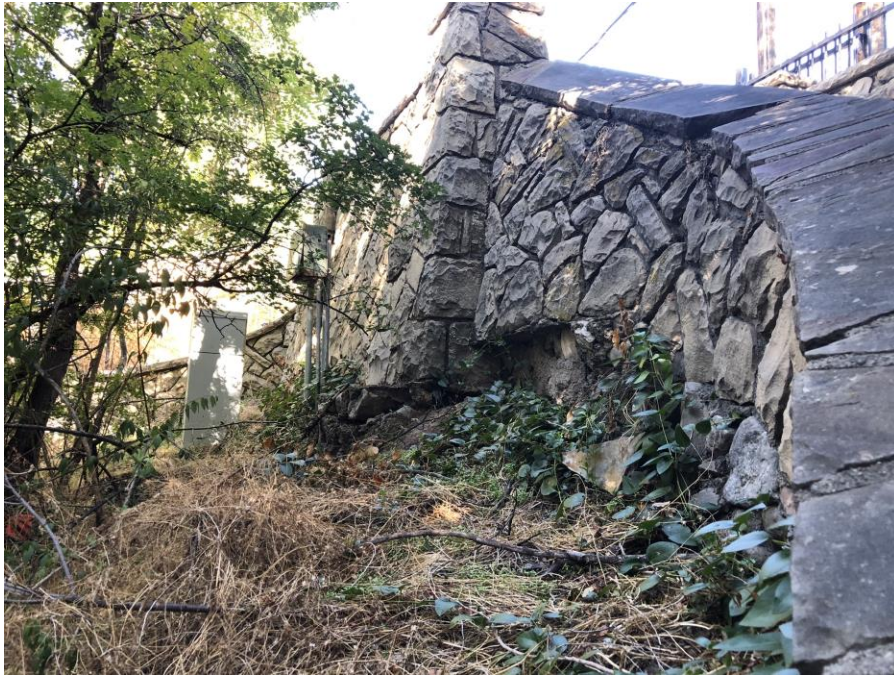
Photo #17 – The existing wall is being undermined and the toe needs to be covered with structural fill.
